# **EVALUATION OF RISK AND POSSIBLE MITIGATION SCHEMES FOR PREVIOUSLY UNIDENTIFIED HAZARDS**

William Linzey, Micah McCutchan, and Michael Traskos  
Lectromechanical Design Company

## **Preface**

In April 2004, the NASA Engineering and Safety Center (NESC) was commissioned by NASA's Chief Safety and Mission Assurance (S&MA) Officer to review and render a technical opinion on the probability of a catastrophic failure related to this scenario: The Space Shuttle Program (SSP) recognized a zero-fault-tolerant design related to an inadvertent firing of the primary reaction control system (RCS) jets on the Orbiter during mated operations with the International Space Station (ISS). It was determined that an un-commanded firing of an RCS jet could cause serious damage or loss of both the SSP Orbiter and the ISS. Several scenarios were suggested in which an un-commanded firing of the RCS jet is possible [1]. These scenarios include an arc track event in the 28-volt heater circuits that could result in a wire-to-wire short to the adjacent reaction control jet wire. In this worst-case scenario, enough current and power could be applied to activate the reaction control jet valves and fire a

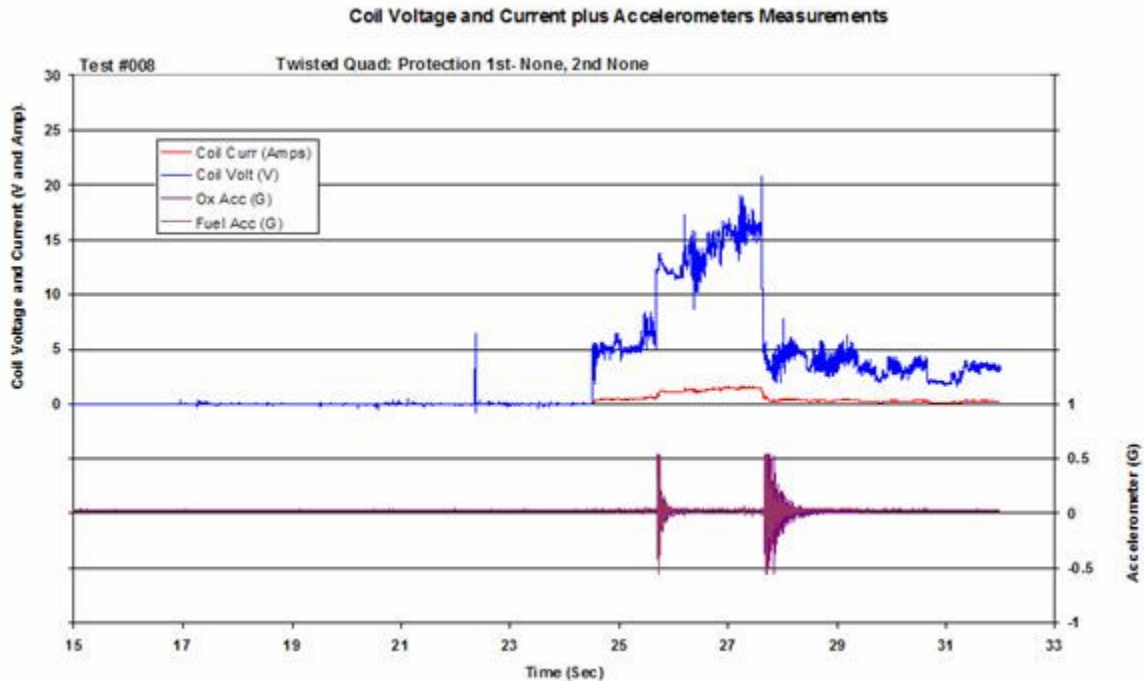
**Figure 7. Coil Current and Voltage Traces along with Accelerometer Measurements for Test 008**

Figure 7 shows the coil voltage and current traces along with the accelerometer reading for Test 008 in which the fuel/ox valve opened. Just before the 26 second mark, ~5 volts (blue line) was measured across the coil with an associated current, < 0.5 amps (red line), measured through the coil. This indicates that the insulation of the fuel/ox wire feeding the high side of the coil was compromised and there was arcing directly to the conductor of that wire. This arcing current returned to ground through the coil with the resistance of the coil (~11.5 ohms) limiting the current. At this voltage/current level the coil was not activated, and the valve remained closed. After ~0.5 seconds the arcing produced a higher voltage across the coil (~12 volts) and the coil activated. The valve opened as recorded by the accelerometers (violet line). Note that the second accelerometer also recorded the opening, but since the traces overlap, it cannot be seen. The voltage across the coil rose to over 15 volts and then collapsed as the fuel/ox return wires also became directly involved in the arc. It was impossible to maintain a voltage across the coil (see discussion of Figure 8 in the next paragraph). The accelerometers also recorded the closing of the valve at about 28 seconds.

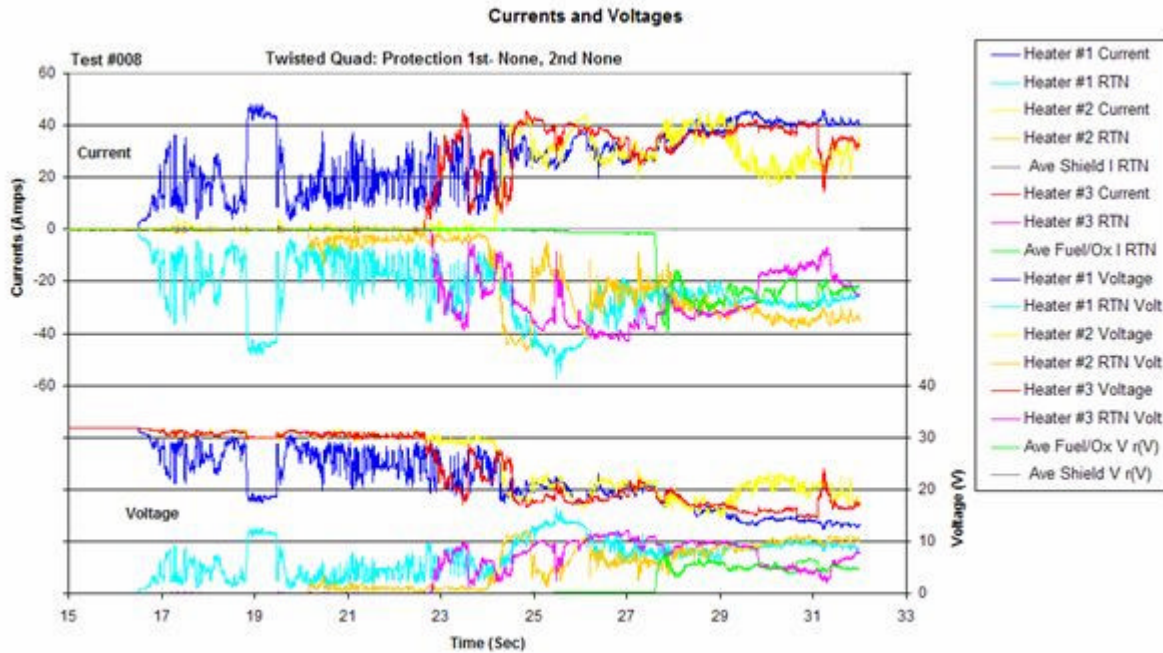
**Figure 8. Current and Voltages in the Arcing Event in Test Specimen 008**

Figure 8 shows the current (upper traces) and voltage (lower trace) of the arcing wires for Test 8. The darker blue line in the upper trace is the feeder current for the wire in which the arc was initiated (heater #1). The lighter blue line is the return current for heater #1, which by convention is negative. The dark blue line in the lower trace is the voltage at the point when the specimen is attached at the end of the feeder.

Figure 8 also shows the current for the first few seconds of the arc varied greatly, but that it averaged around 15 amps. At this time, the arc voltage (the difference between the dark and light blue lines in the lower traces) was ~ 20 volts. At ~19 seconds, the arc current rose to 40+ amps for 0.6 seconds as the arc propagated through the first spot-tie. Note that the arc voltage was reduced to less than 10 volts as the increased current caused a higher voltage drop in the feeders. This shows the regulatory effect of the feeder resistance because, as the arc current increases, the arc voltage is reduced. The 15 amp fuse did not open at this point because the duration of the current peak was not long enough for this to occur. At the 20-second mark, the return for heater #2 (gold line) became involved in the arc. At this point in time, the heater #1 wire arced to both the heater #1 and heater #2 returns. At about the 22.5 second mark, the heater #3 wire became involved in the arc followed a short time later by the red return. At ~24 seconds, the heater #2 wire also became involved in the event. At this time, the fuel/ox wires had not become involved in the event, but as shown in Figure 7, this changed at ~26 seconds. The activation of the coil can be seen in Figure 8 by observing the slight drip in the fuel/ox return current (green line) as the coil current is returning via the wire. The return current jumps to more than -20 amps, at just over 27 seconds, since there is arcing directly to the fuel/ox return. This causes the coil voltage to collapse and the valve to close.

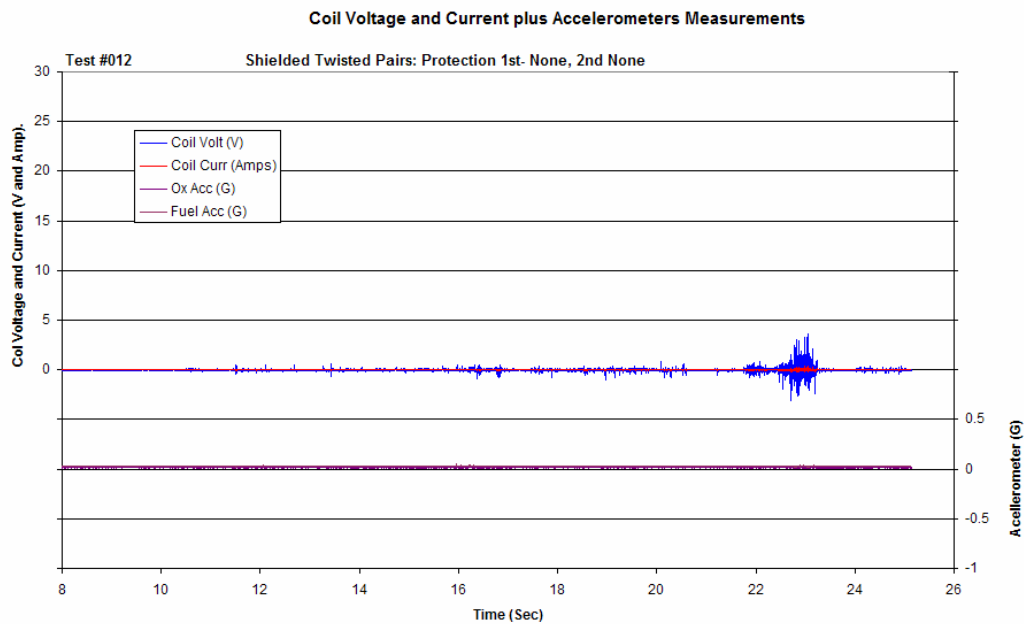
**Figure 12. Voltage and Current across the Coil and Accelerometer Measurements for Test Specimen 012**

Two groups (011-015 and 76-80) were placed in this category. The fuel/ox wires of the former were unprotected, shielded twisted pairs and the latter were twisted pairs (non-shielded) protected with one wrap of PTFE tape. Figure 12 shows the voltage and current across the coil for Test 012. There is no activity except oscillations of a few volts after the 22-second mark. These oscillations were most likely from electrical noise generated by the arcing event. The fuel/ox wire from Test 012 passed the wet DVW test indicating that there could not have been direct current going from the arc to the fuel/ox wire. Thus, there was only a capacitive/inductive coupled current. The sampling rate of the data logger was too low to obtain frequency information for the oscillations. There is no movement of the valve detected by the accelerometers.

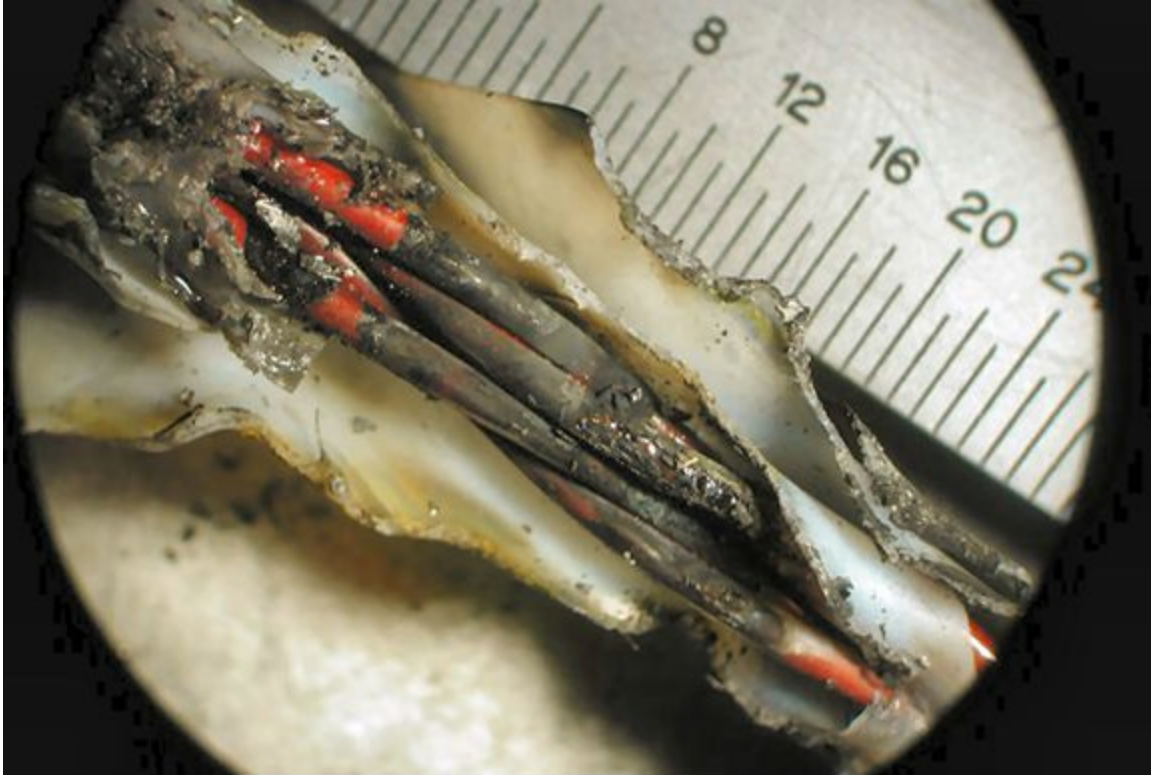
**Figure 15. Post-test Photomicrograph of Fuel/Ox Wire Test Specimen 076**

Figure 15 is a photomicrograph of Test Specimen 076. This was the worst-case damage to the fuel/ox wire of any of the protected specimens. Despite the damage, this wire passed the post-test wet DVW as there was still sufficient wire insulation remaining. There was no voltage or current measured across the coil of this specimen and no valve movement detected by the accelerometers.

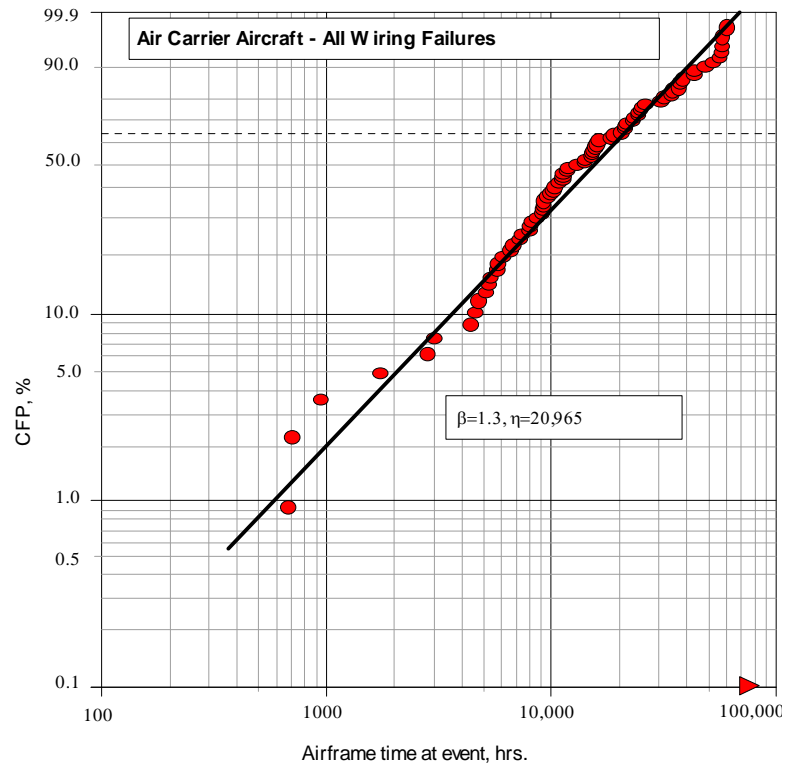
**Figure 1. Weibull Plot of *ALL* Wiring Failures on Air Carrier Aircraft**

All wiring failures (broken, chafed, loose, shorted and “other” failures; 250 relevant occurrences, 92 usable for Weibull) are shown in Figure 1. These data fit a Weibull distribution well ( $P_{ve} = 41.6\%^{\ddagger}$ ). For *all* wiring failures, air carrier aircraft show “early wear-out” failures as indicated by a Weibull slope ( $\beta = 1.3$ ) greater than one.

Weibull analyses typically are performed “one failure mode at a time”. That is, mixtures of failure modes can confound the data. Although Figure 1 does exhibit a good statistical fit, there is some indication modes are mixed: several lower points diverge from the main (center) distribution as do the last upper (longest time) points. Thus data were analyzed further using separate failure modes.

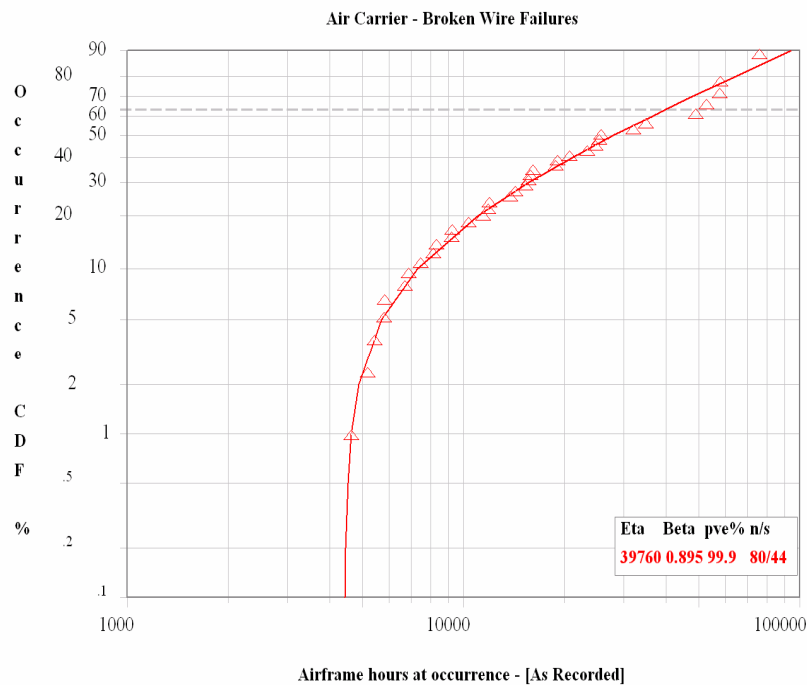
**Figure 2. Weibull Plot for Air Carrier Broken Wire Failures**

Broken wires (94 failures) initially showed a good two-parameter fit (Pve = 12.5%) with early wear-out failures ( $\beta = 1.5$ ) indicated. However, the first failure (at 1754 hours) strongly influenced the distribution. This broken wire occurred in a B737-700 causing an engine fire. Its early occurrence suggested infant mortality. Censoring this datum yielded a poor two-parameter fit (1.5%), but the curved shape suggested a three-parameter Weibull distribution. A three-parameter fit was excellent (99.9%) with  $\beta = 0.90$  and  $\eta = 39,800$  hours indicating nearly random failures ( $\beta \sim 1$ ), as shown in Figure 2. Time offset ( $\gamma$ ) was 4,433 hours, that is, 4400 hours passed before the broken wire failures commenced.

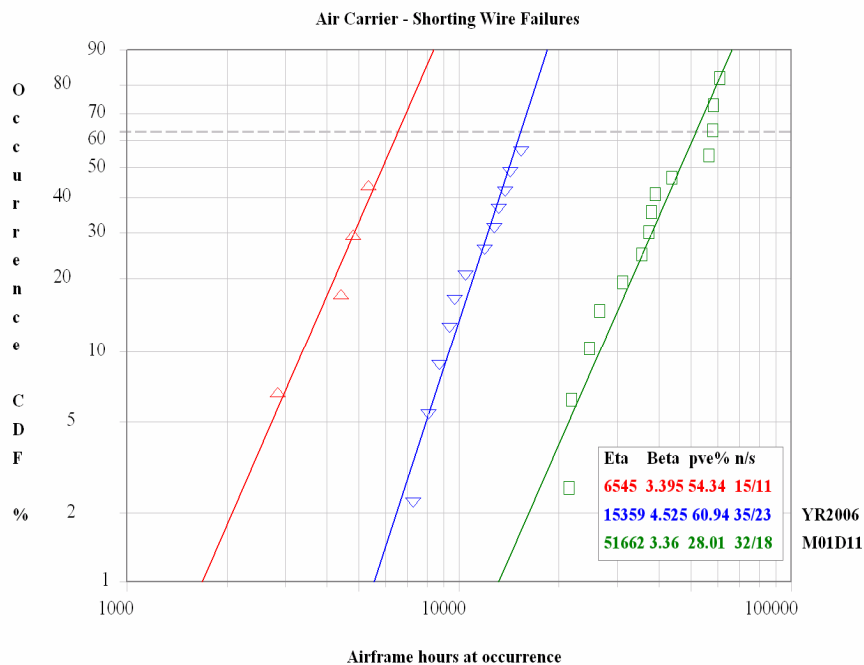
**Figure 3. Shorted Wire Failures in Air Carrier Aircraft**

The initial analysis for shorted wires (97, 31 Weibull usable) indicated early wear-out failures ( $\beta = 1.5$ ,  $\eta = 42,000$  hours, Pve = 52%). This plot showed several breaks with three or four subpopulations. These distributions were separated and plotted, as shown in Figure 3. There are three, possibly four, failure distributions with all showing greater  $\beta$ s (3.4 to 4.5) pointing to wear-out or near wear-out failures. A contour plot (Figure 4) compares three failure distributions within shorted wires:  $\beta$ 's are equivalent (contours overlap along the vertical, beta, axis), but they are separated along the eta (time) axis.

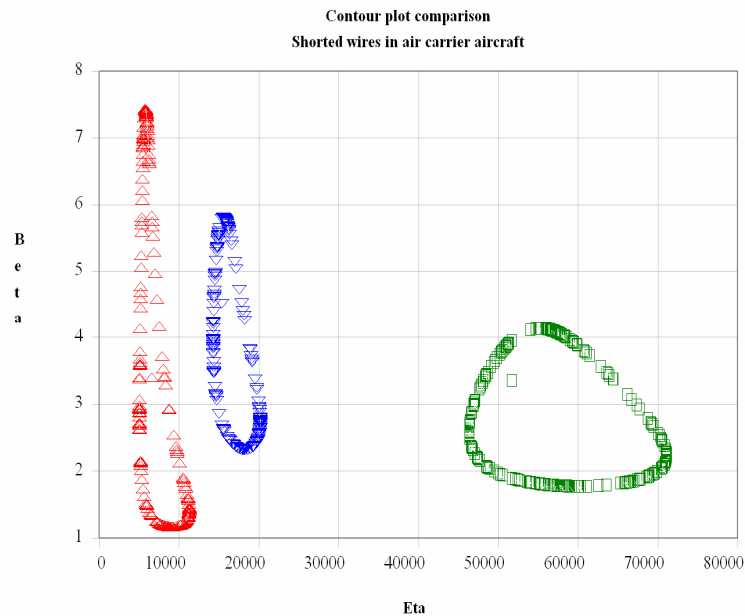
**Figure 4. Comparing Weibull Parameters for Shorted Wires in Air Carrier Aircraft (90% confidence intervals)**

As this three distribution model is credible, aircraft wiring shorts likely manifest as wear-out failures distributed over a range of operational times. These several “large  $\beta$ ” distributions combine over a wide time scale to produce an apparent lower- $\beta$  early wear-out distribution.

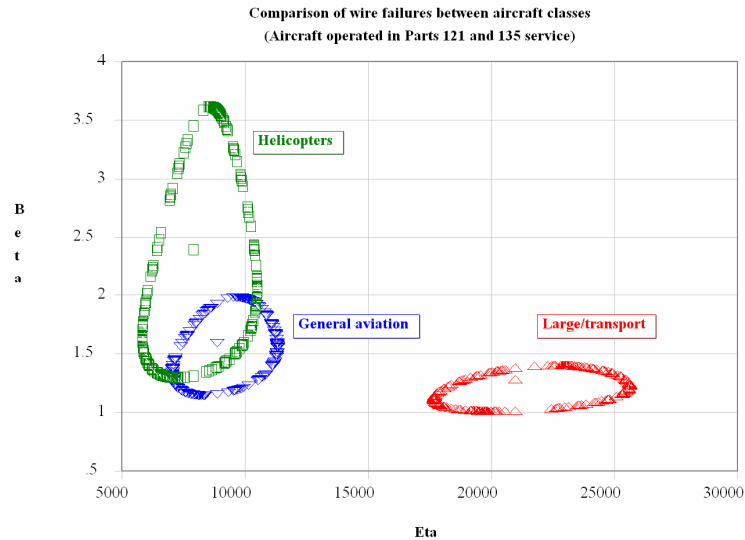
**Figure 5. Comparison of Wiring Failure Distributions Between Helicopters, General Aviation and Large/Transport Aircraft used in Air Carrier/Air Taxi/Commuter Service**

A contour plot (Figure 5) compares these wiring failures. Helicopters and general aviation aircraft wiring failures have  $\beta$ s equivalent to those for large/transport aircraft. However, helicopter and general aviation aircraft failures occurred much sooner – note the distinct separation between *etas* (time axis). Thus general aviation aircraft (and helicopter) wiring failures do occur earlier than those in large aircraft. No cause (why general aviation failures occur earlier) can be determined from these data.

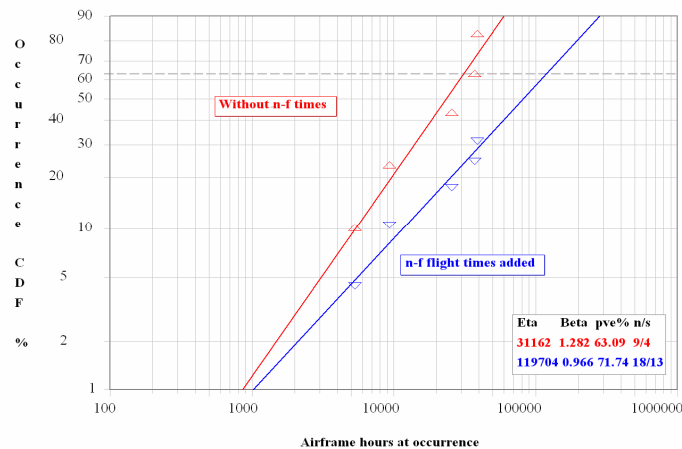
**Figure 6. Accounting for Non-Failed Flight Hours, SF-340 Aircraft**

An example illustrates including non-failed operating times. The SAAB SF-340 aircraft was considered. Annual in-flight operating times were taken from the *Transtat* database<sup>§</sup>. Figure 6 is a Weibull plot with and without non-failed operating times (suspensions). Adding non-failed data pushed the failure distribution down the probability axis and slightly diminished its slope. This is expected since adding right suspensions alters the failure ranks. Characteristic life also increased substantially. Another example using data for CE-402 aircraft showed similar results: its bi-modal distribution increased  $\eta$ s (7720 to 15,000 hours and 17,400 to 21,400 hours) and decreased  $\beta$ s (2.2 to 2.1 and 11.5 to 9.3) when non-failed flight hours were added.
